Manhole Inspection Summary

Manhole # S53O__022MH

Insp Date: **4/17/08 7:46 AM**

Location Address: **1002 elliottt street**

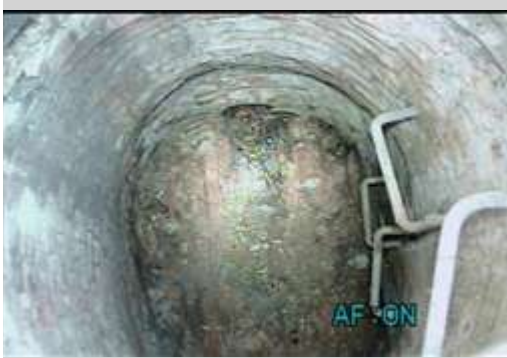
Defect 1

☒ **Corroded**

steps

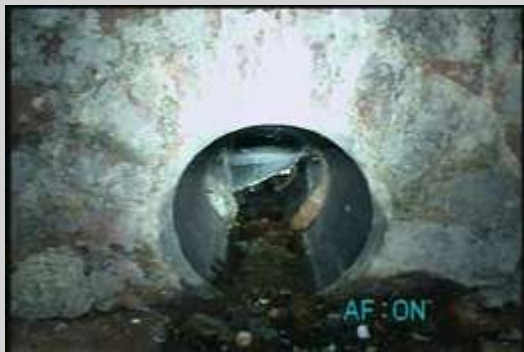
12 O'Clock Outflow

8 in. Circular Gravity Sewer
Pipe Out @ 12 O'Clock
